Taming reflections with the large format CCD

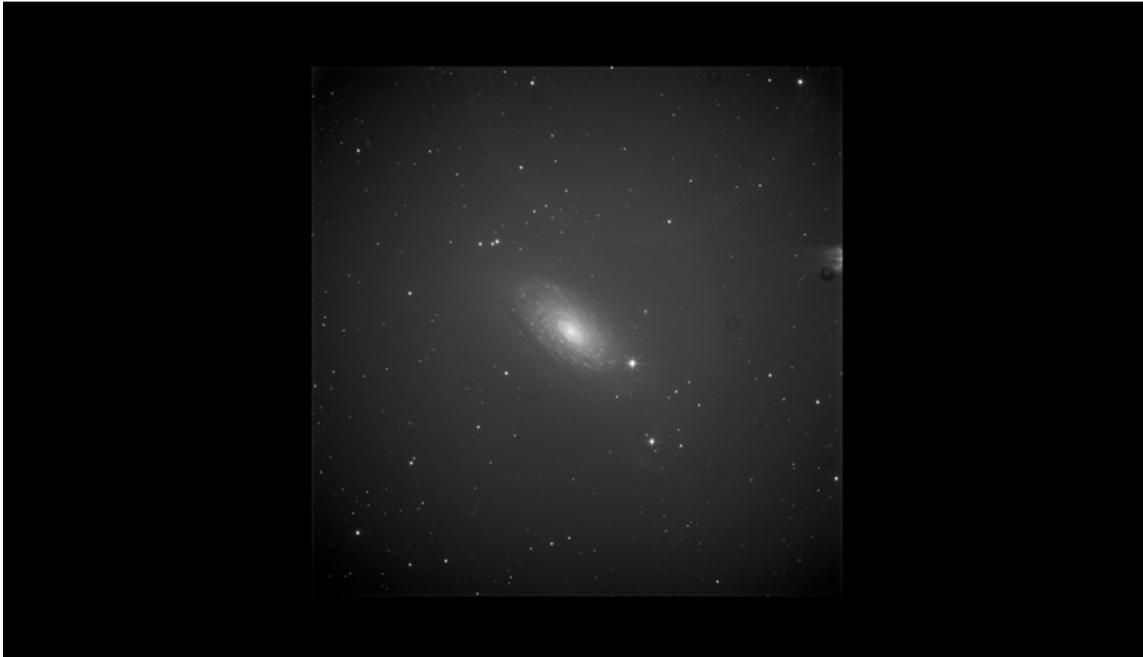
This image was taken with a U9000 with BBAR coated window and the two aperture masks installed. It is a single 900 second exposure of M63. Notice the arc ring textured reflection on the upper part of the frame. Also notice the “smear” type reflection from the bright star on the left. There is also a “sky concentration” hot spot in the center. Notice in the picture below that this doughnut hot spot shows up in the flat and does seem to flat out.

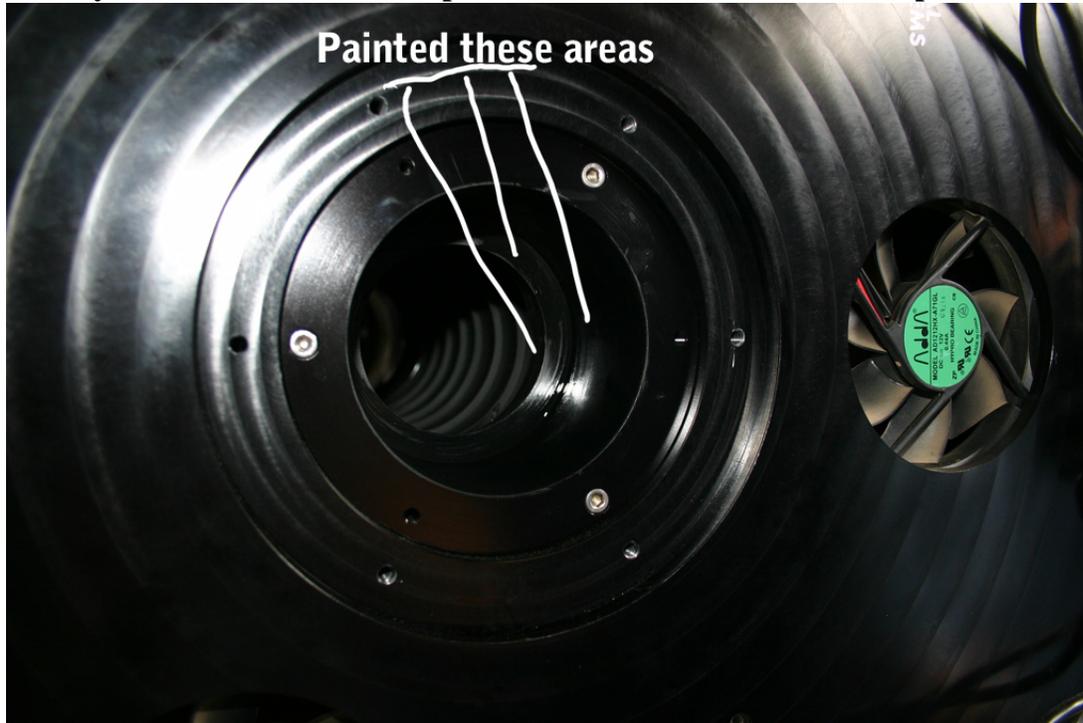
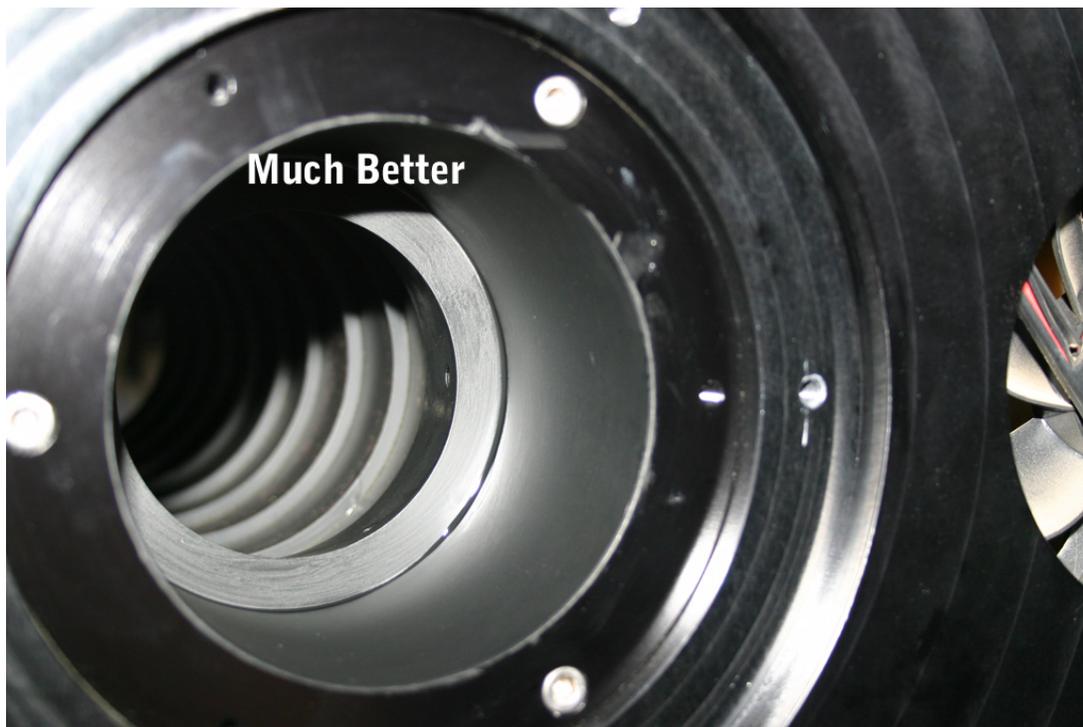
As we all know, anodized surfaces are highly IR reflective and the scattered light seems to be hitting these surfaces. Removing the PIR you will notice a chamber in the back plate and the neck through to the primary baffle tube. The neck area contains the set screws that hold the mirror spacers in place. These areas are smooth anodized surfaces with a ring area pointing directly at the field corrector. I painted these areas with flat black paint.

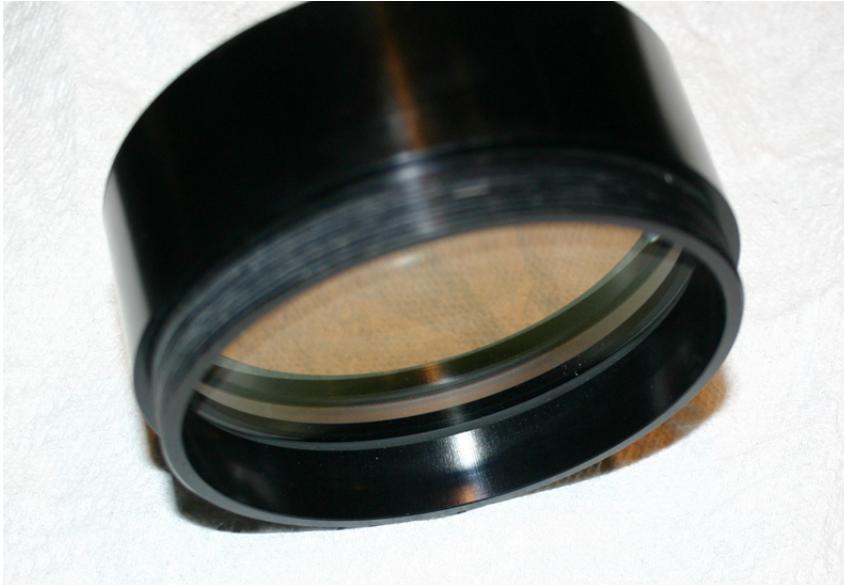
Inside the field corrector is very shiny black anodized material. The edges of the glass sits right up against this and are not masked.

I believe this is a huge portion of the problem as the reflections have a textured look. This is the 100mm Field Corrector which is like a 4" refractor! I believe this should be build like a refractor objective cell with very dull black insides with a small edge mask. As you can see there is a large amount of reflection possible here.

First I painted the retaining ring with flat black paint and then flocked where I could on the inside of the tube.

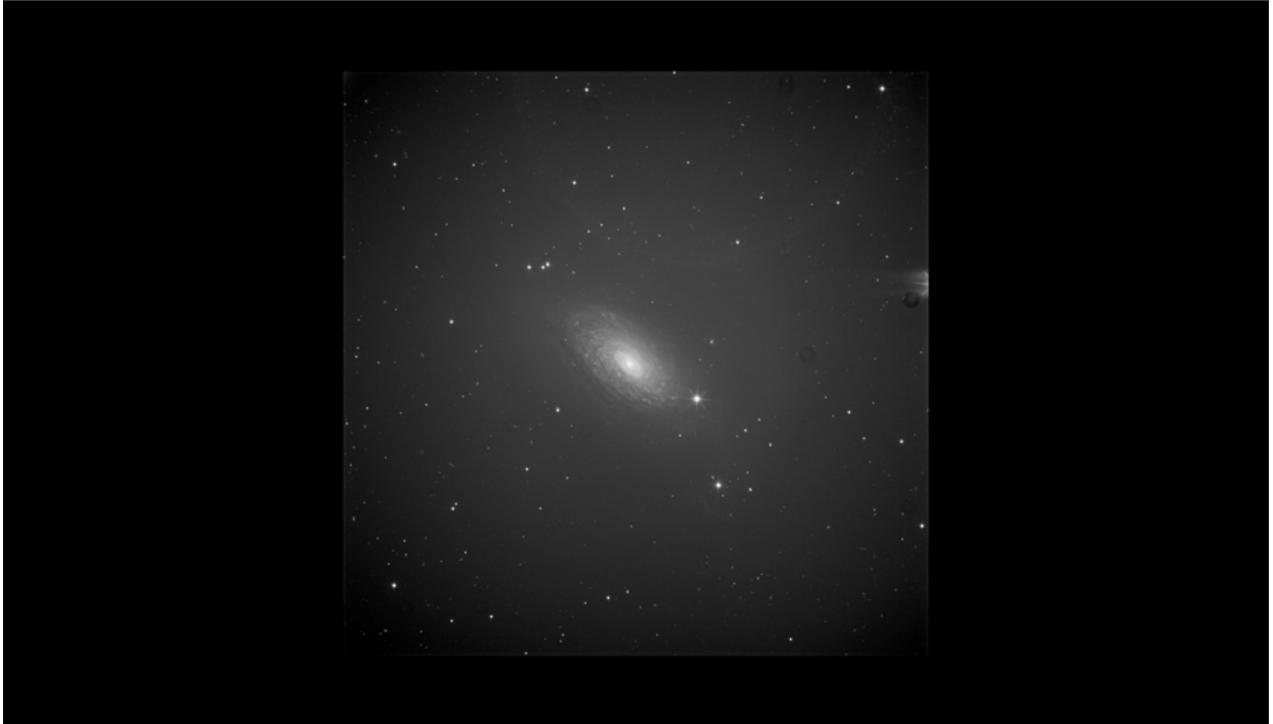
Once I completed these steps I wanted to test the results with the field corrector removed and not in the image path. This is the image with the Field Corrector (FFC) in place.

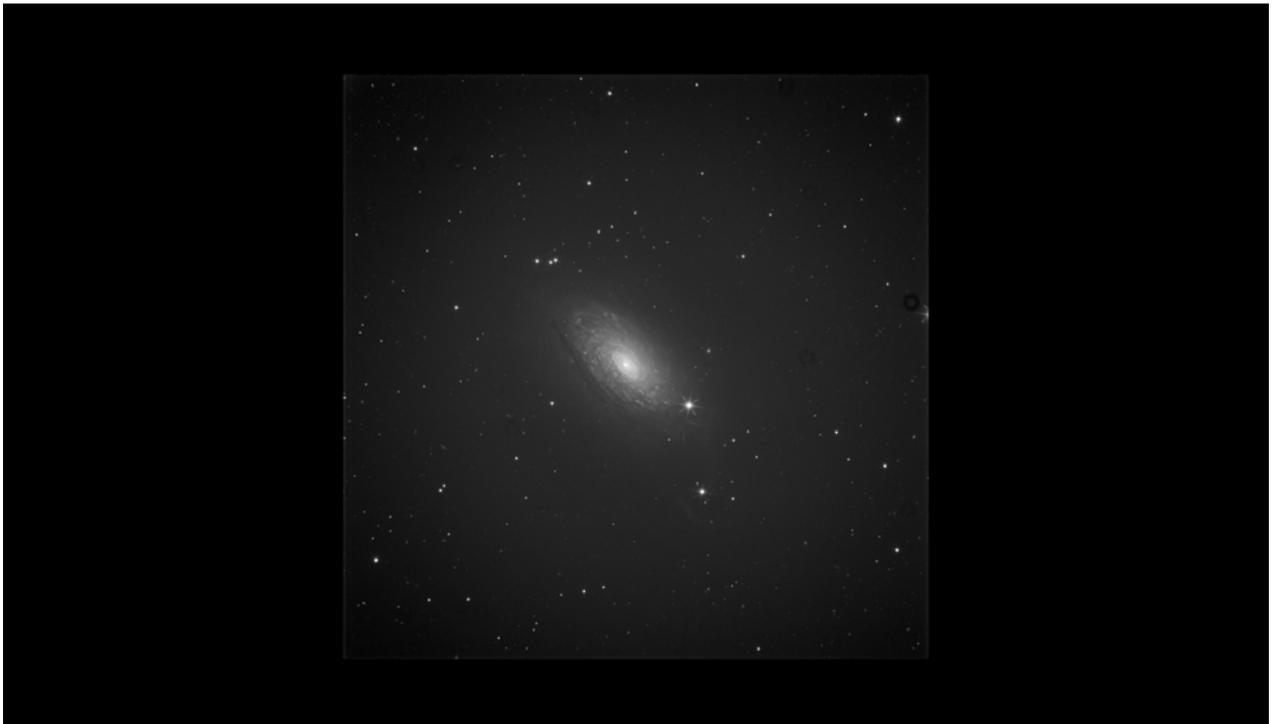
This is the image after removing the Field Corrector – no reflections and normal hot spot.

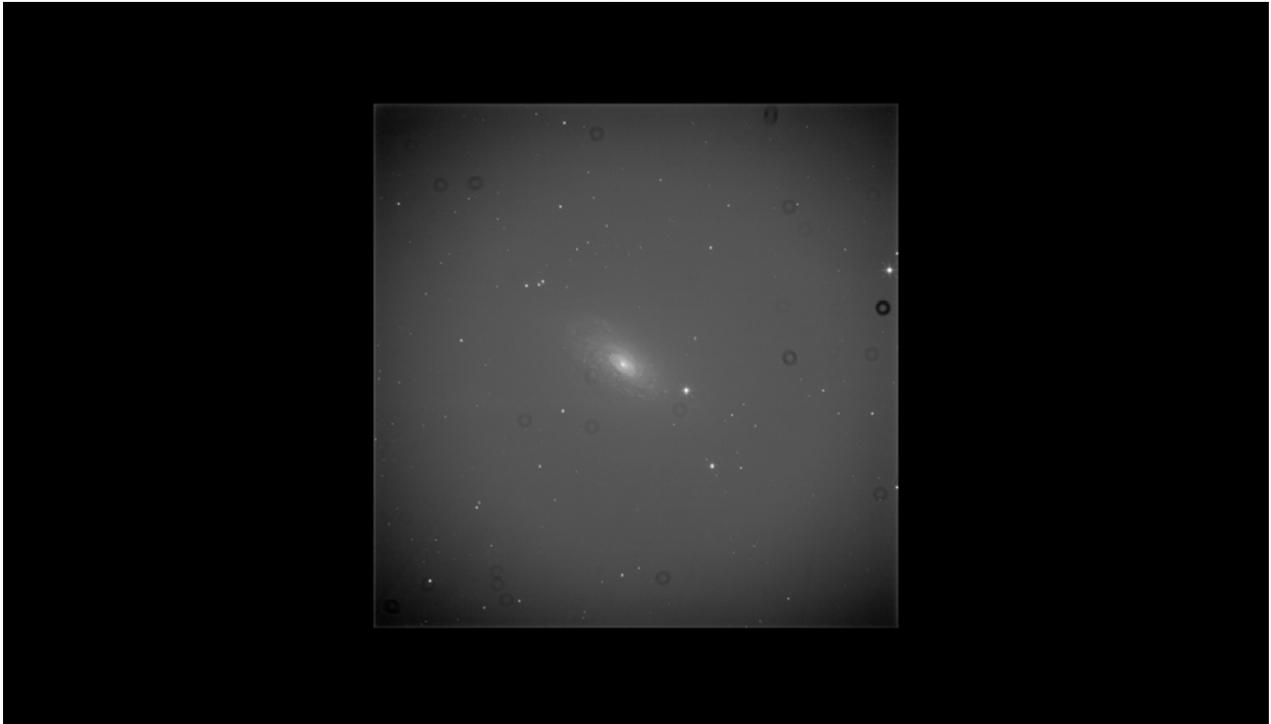
M63 with FFC after Modifications (3/4 moon)

This test was done with a $\frac{3}{4}$ moon but the hot spot doughnut (sky concentration) is now much wider and more diffuse. The “sky concentration” has been improved and the reflections tamed doing these simple mods.
