Taming reflections with the large format CCD

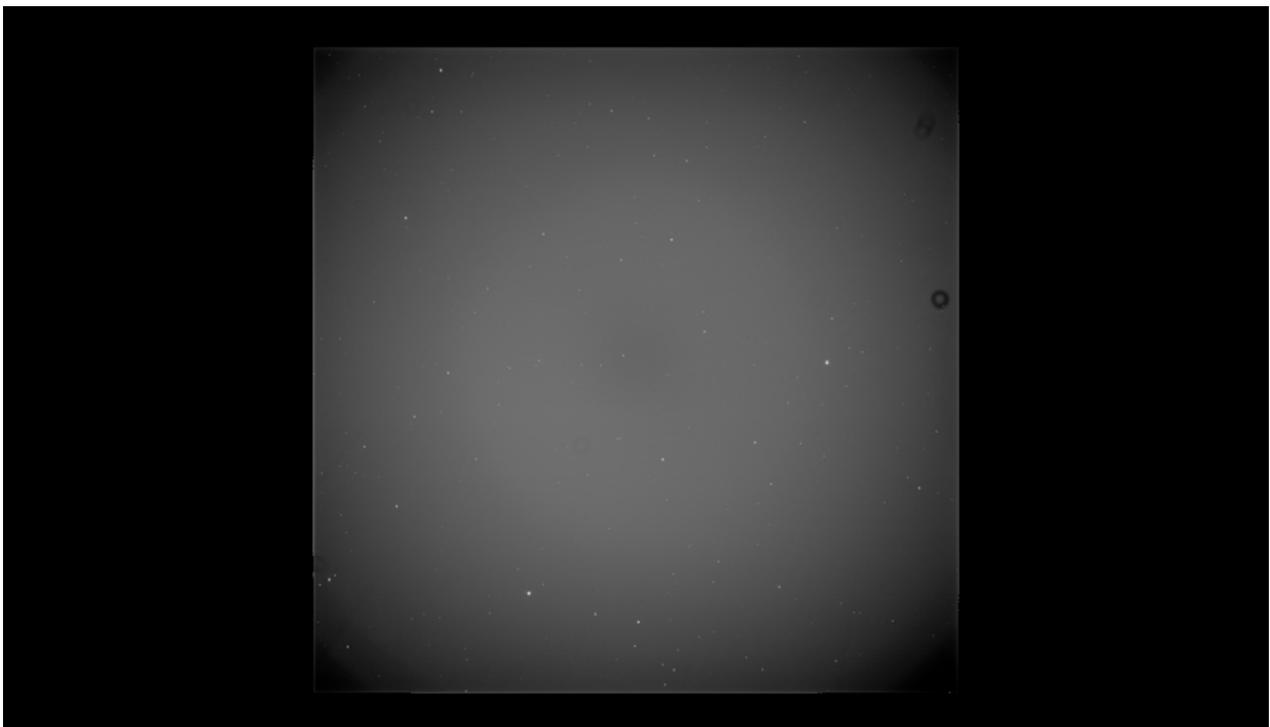
This image was taken with a U9000 with BBAR coated window and the two aperture masks installed. It is a single 900 second exposure of M63. Notice the arc ring textured reflection on the upper part of the frame. Also notice the “smear” type reflection from the bright star on the left. There is also a “sky concentration” hot spot in the center. Notice in the picture below that this doughnut hot spot shows up in the flat and does seem to flat out.

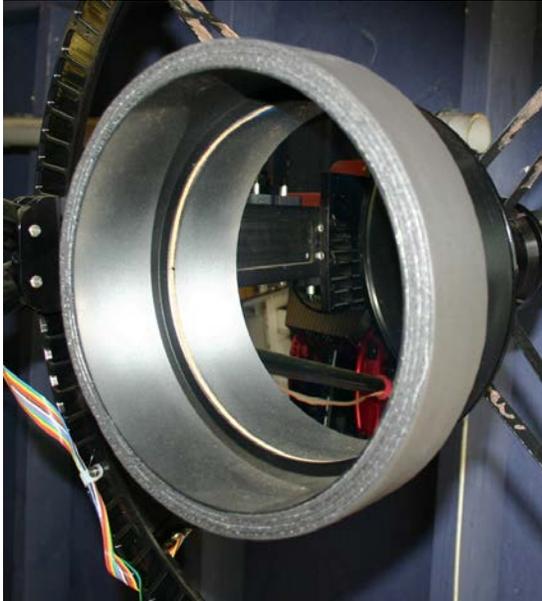
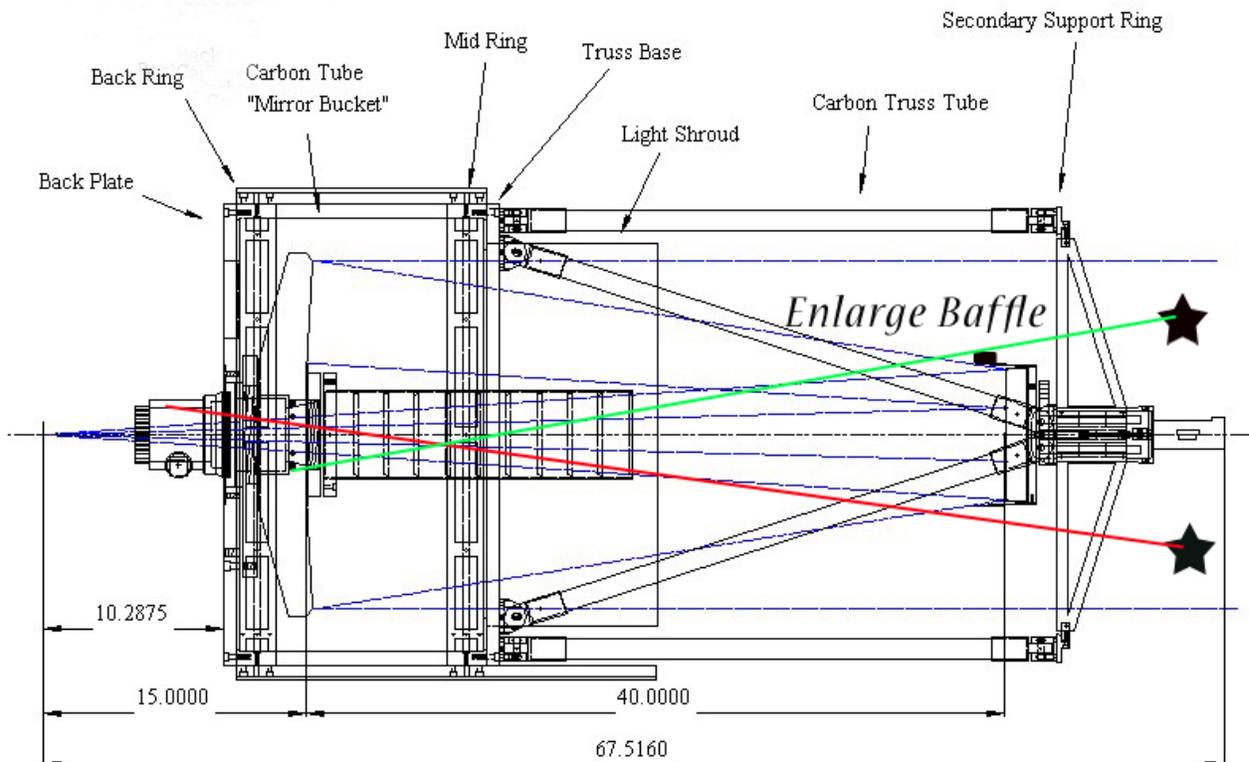
20RC Truss Telescope

With the large CCD (KAF 09000 or KAF16803) scattered light can become a real issue. One step that should be done is make sure any stray light that can get past the secondary baffle and scatter off of something in the image train and hit the chip. In my case, stray light was scattering around the field corrector causing most of my problems. I applied 4 layers of 1/8" black foam insulation tape around the secondary baffle tube to make the off axis light get caught farther up the primary baffle tube away from my field corrector. This alone helped but did NOT eliminate the problems.

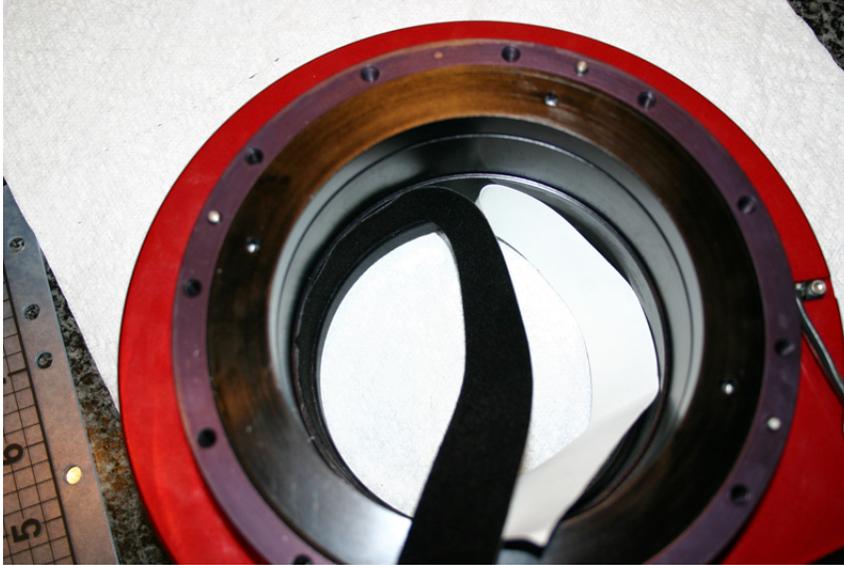
The PIR is beautiful and it houses the field corrector if you have one. Again there are very reflective surfaces there that can scatter into the field corrector and reflect off the edge of the glass. I flocked the area that is visible in front of the FFC.

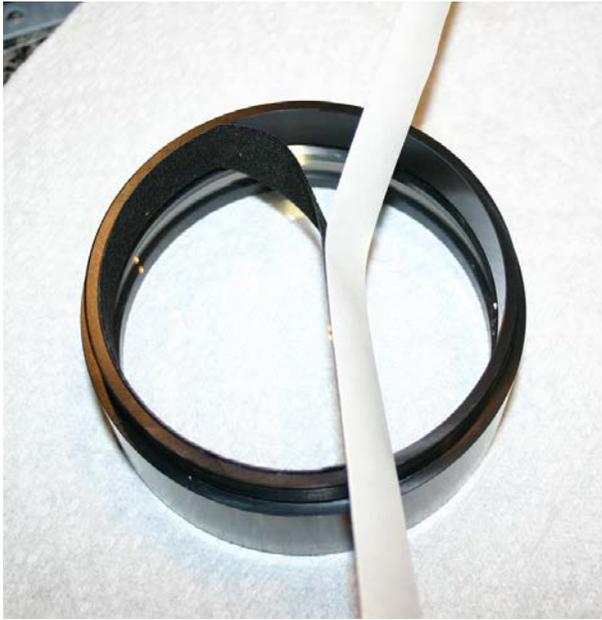
Inside the field corrector is very shiny black anodized material. The edges of the glass sits right up against this and are not masked.

I believe this is a huge portion of the problem as the reflections have a textured look. This is the 100mm Field Corrector which is like a 4" refractor! I believe this should be build like a refractor objective cell with very dull black insides with a small edge mask. As you can see there is a large amount of reflection possible here.

First I painted the retaining ring with flat black paint and then flocked where I could on the inside of the tube.

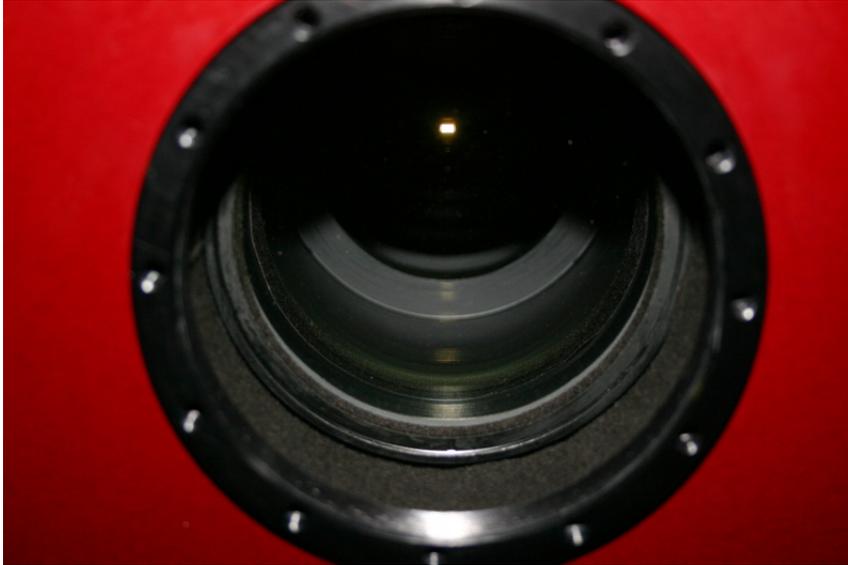
This is a picture of the 100mm PIR and Field Corrector ready to go.

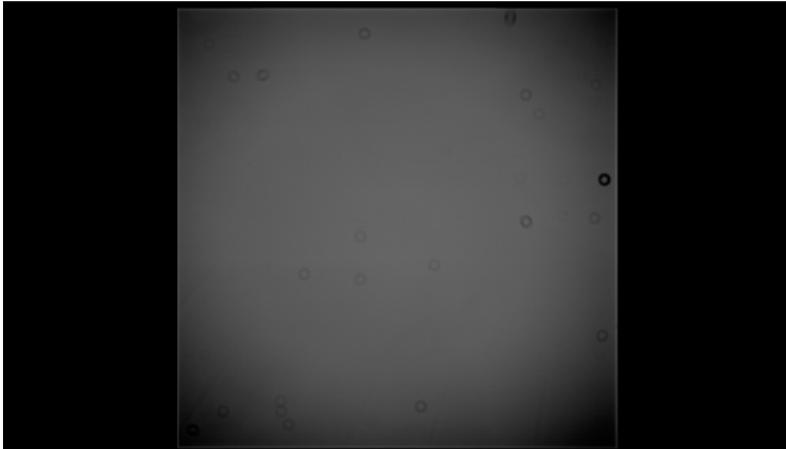
Clear Flat result with all the modifications

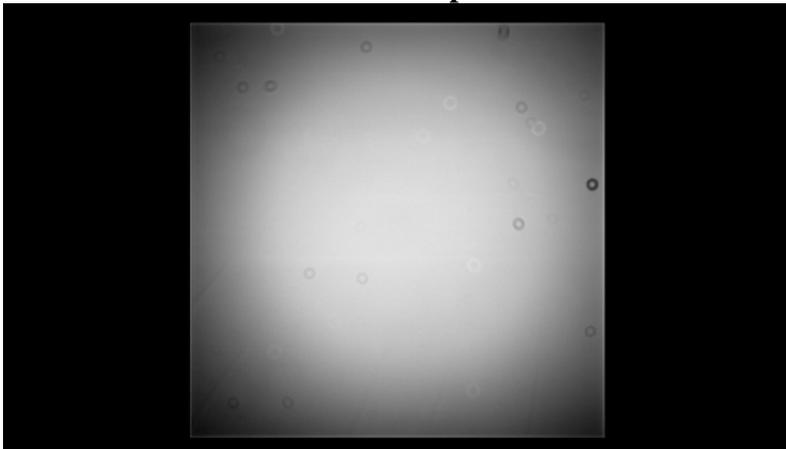
Clear Flat result with no FFC in place.
